UPROAR

Technical Notice **ARF**

Please follow these additional steps to complete the Tower Uproar.

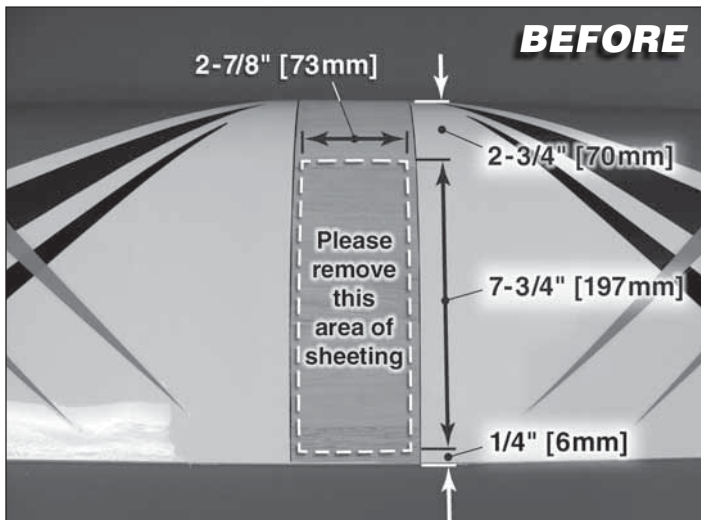
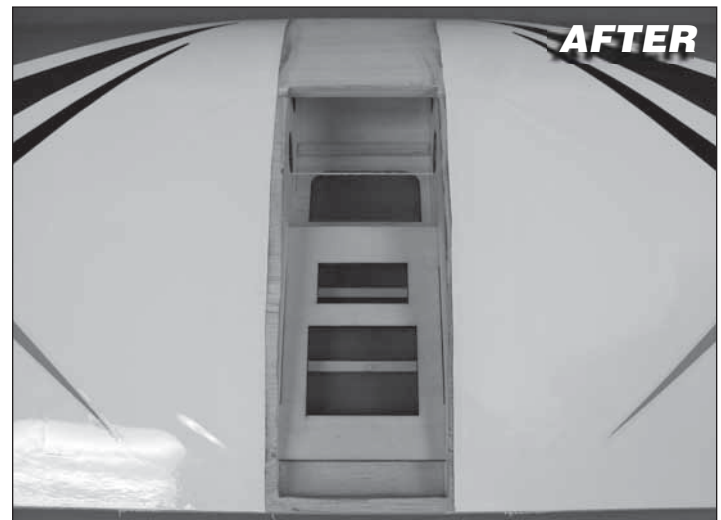
On Page 7, after completing step 8 it may be necessary to remove the balsa sheeting over the servo tray.

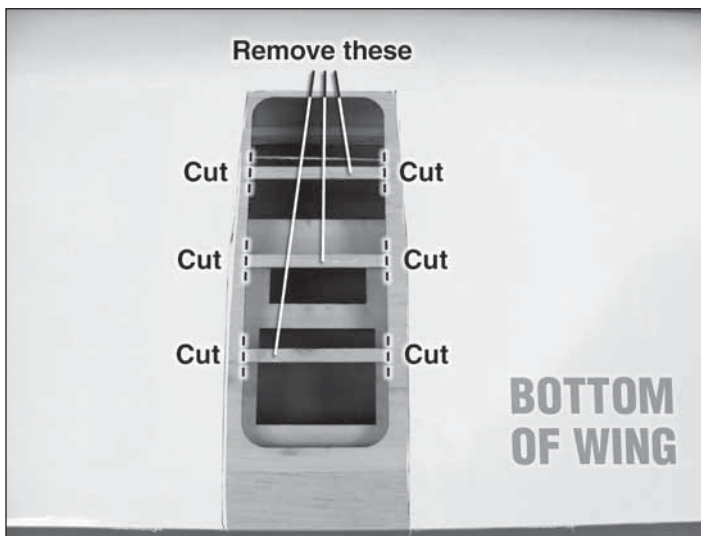
It also may be necessary to remove the cross braces on the bottom of the wing under the covering.
